Poster Presentation

14.2 REMEDIATION OF LAND IN ISRAEL CONTAMINATED BY ASBESTOS CEMENT WASTE MATERIAL

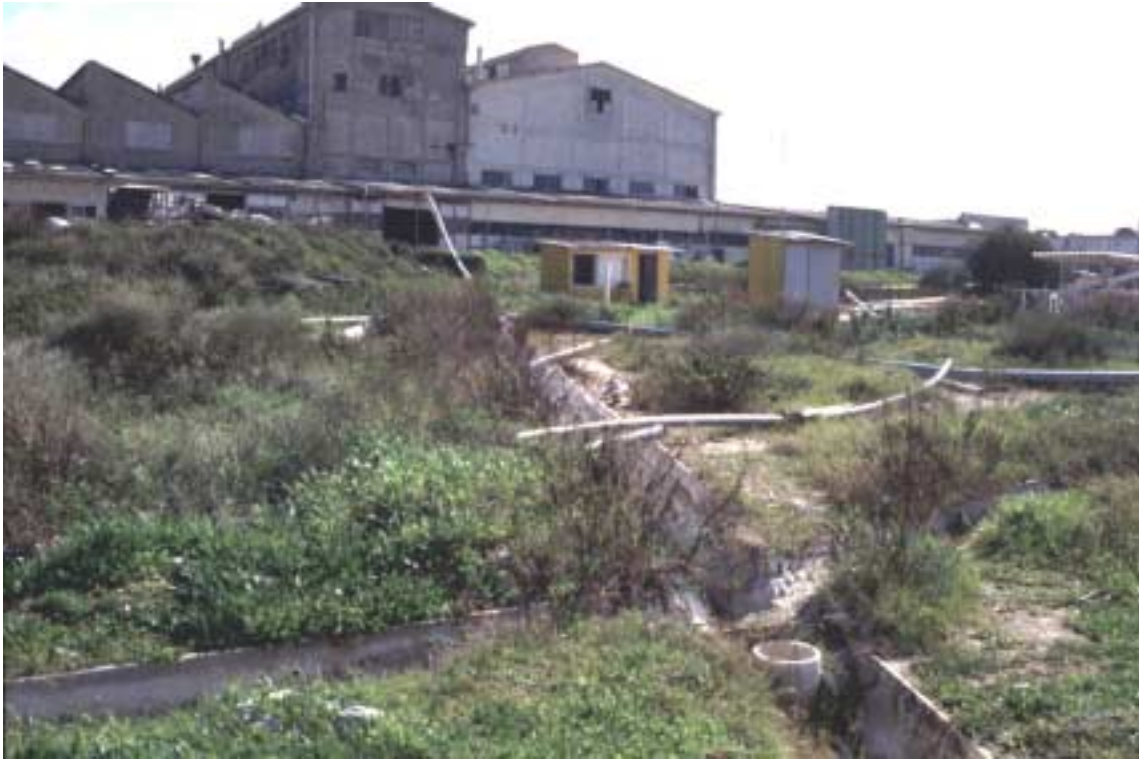
From 1952 to 1997, a plant in northern Israel manufactured asbestos-cement pipe and sheet products, using chrysotile, crocidolite and amosite asbestos fiber. An aerial view of this plant is shown in **Figure 1**. The friable and non-friable waste material from the manufacturing process (**Figure 2**) was partly disposed of in a slurry that ran through drainage trenches that are shown in **Figure 3**. This slurry contaminated property between the plant boundary and the Mediterranean Sea. Other wastes were buried under the ground in landfills around the plant.

Figure 3. Slurry trenches running downhill from plant. *[Full Size]*

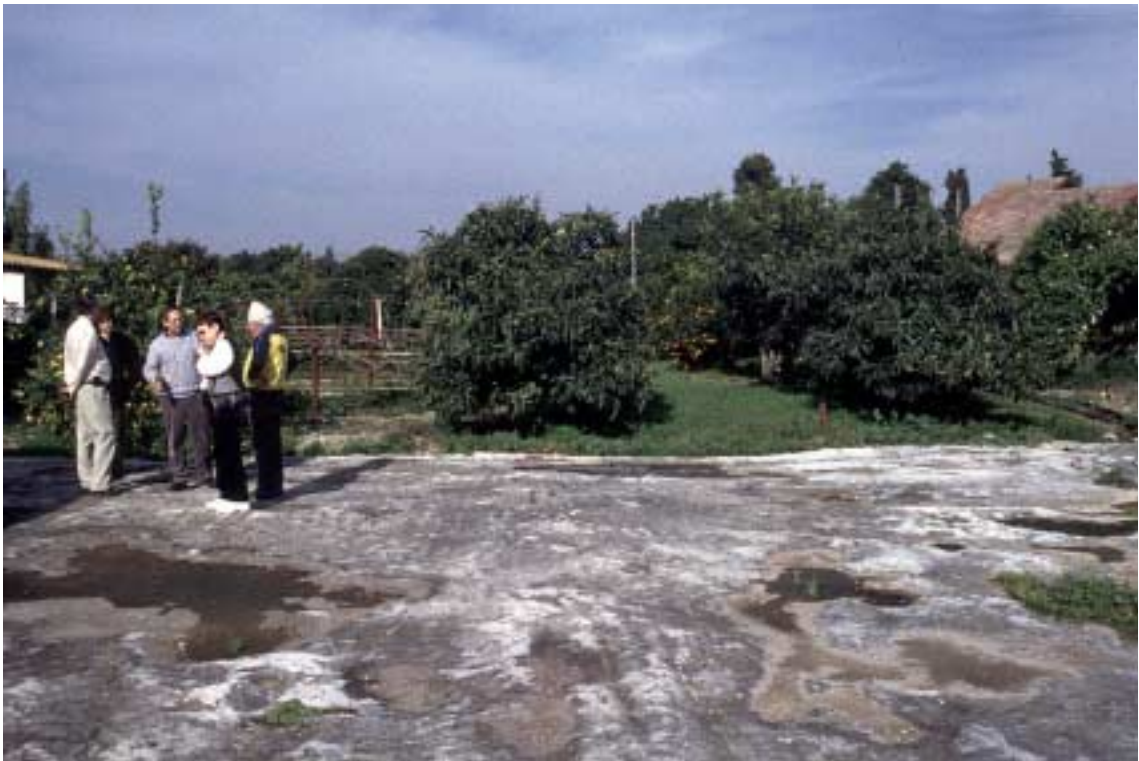
Not all of the asbestos waste material was disposed of around the plant. Some of the “turning waste” – fine dust from beveling the ends of pipe – was given and sold to local residents. It was used to pave driveways, paths and farmyards all over western Galilee as shown in **Figure 4**.

Figure 4. "Cowyard" pavement made from asbestos-cement pipe waste. *[Full Size]*

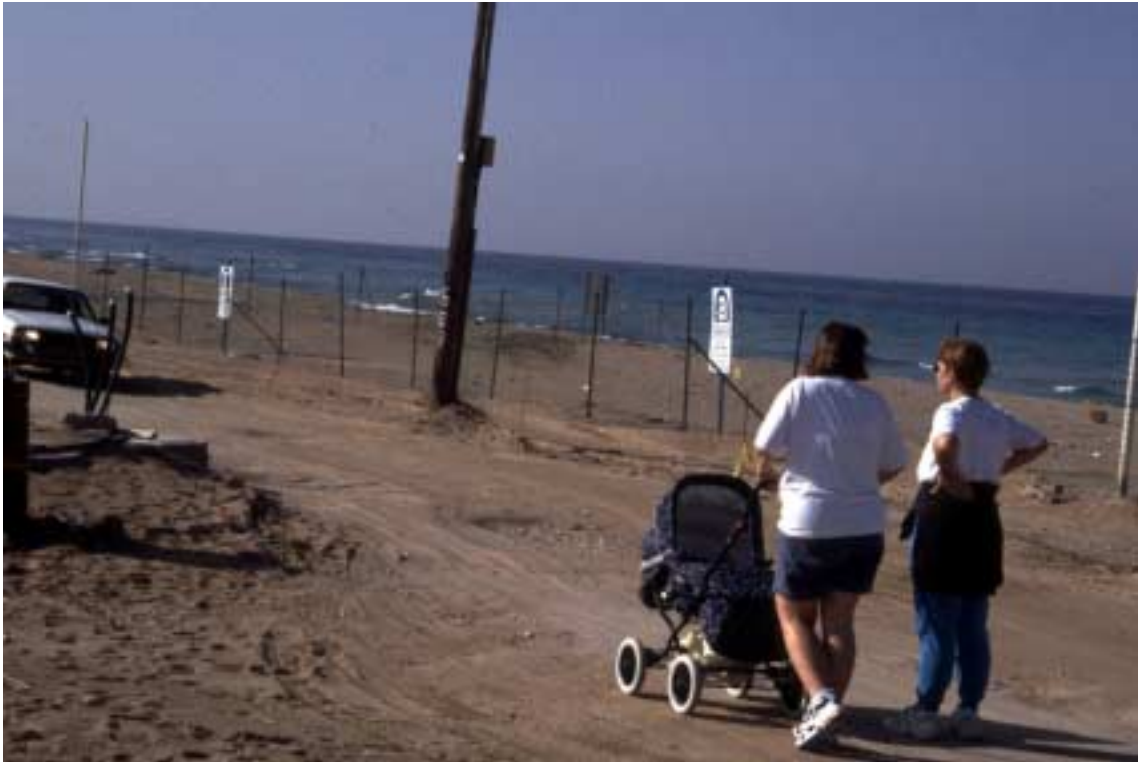
Despite a fence with warning signs (**Figure 5**), residents were observed walking on the contaminated beach. Shortly thereafter, gates were placed across the road at both ends of the park site to limit access to construction workers and Israeli Defense Forces patrols.

Figure 5. Pedestrian and vehicle traffic through contaminated park site. [Full Size]

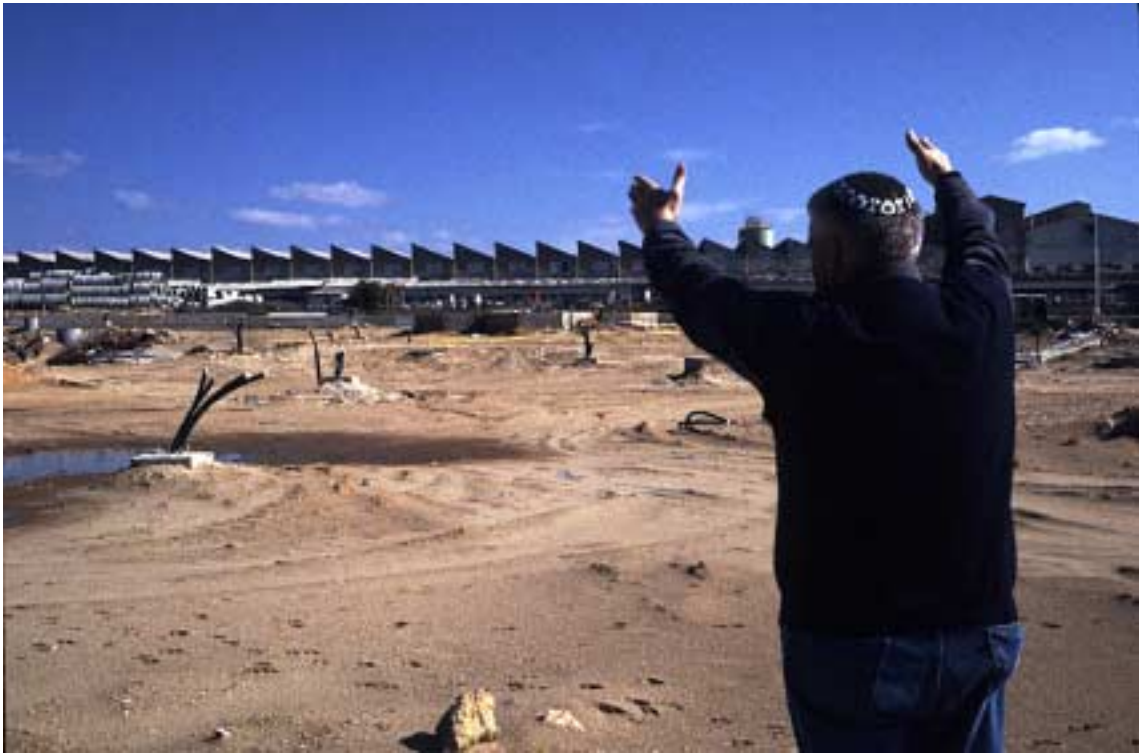
Mr. Oberta visited the plant and park site in 1998 at the invitation of the Israeli Ministry of the Environment. At that time, concrete foundations for the amusement park rides and facilities had been poured and underground electric utilities were in place (*Figure 7*).

Figure 7. View across park site toward plant. Man is indicating location of a former slurry trench. *[Full Size]*

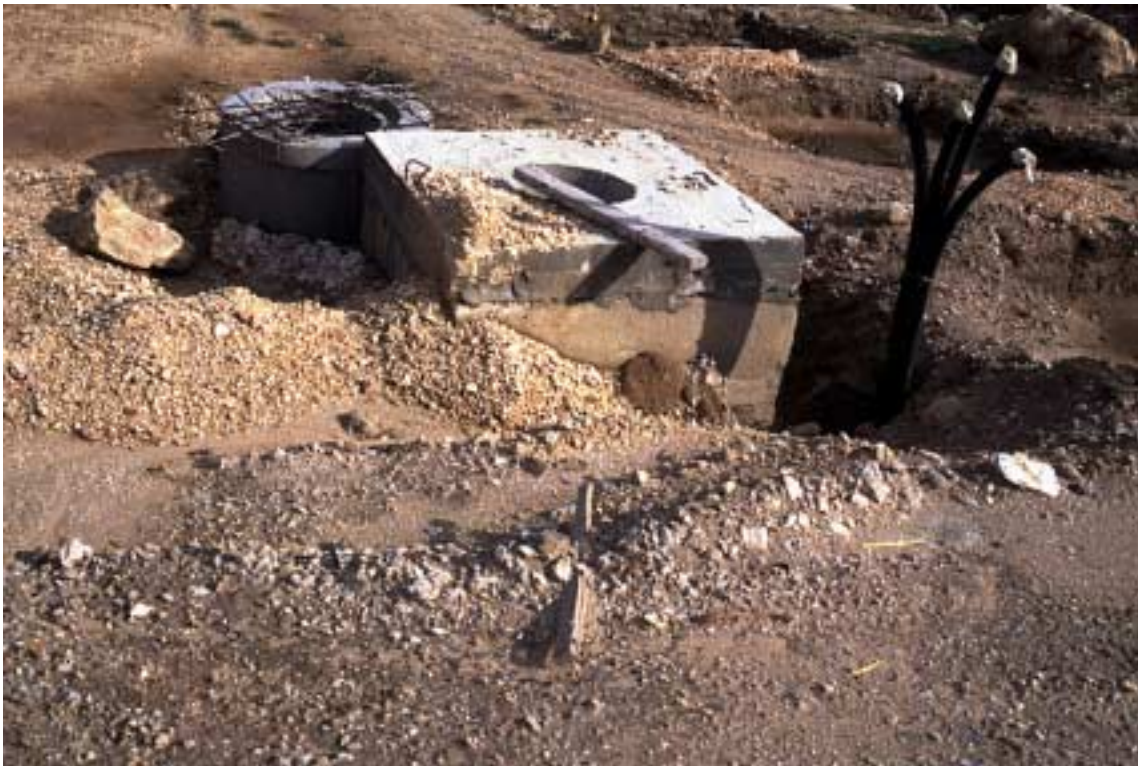
Despite the fact that 15,000 m³ of dirt was removed in 1997, the site was heavily contaminated with visible asbestos debris (*Figure 8*). In addition to pieces of non-friable scrap material, there were large amounts of friable clumps of dried slurry that had overflowed the trenches. This material contaminated the dirt to a depth of 4 m in places, and excavation during construction continually brought it to the surface.

Figure 8. Asbestos debris from excavation on park site. *[Full Size]*

Mr. Oberta made several recommendations in his report to the Ministry, including the installation of a protective barrier at final grade level across the construction site. His recommendation of closing the patrol road to keep residents off the site was promptly implemented.

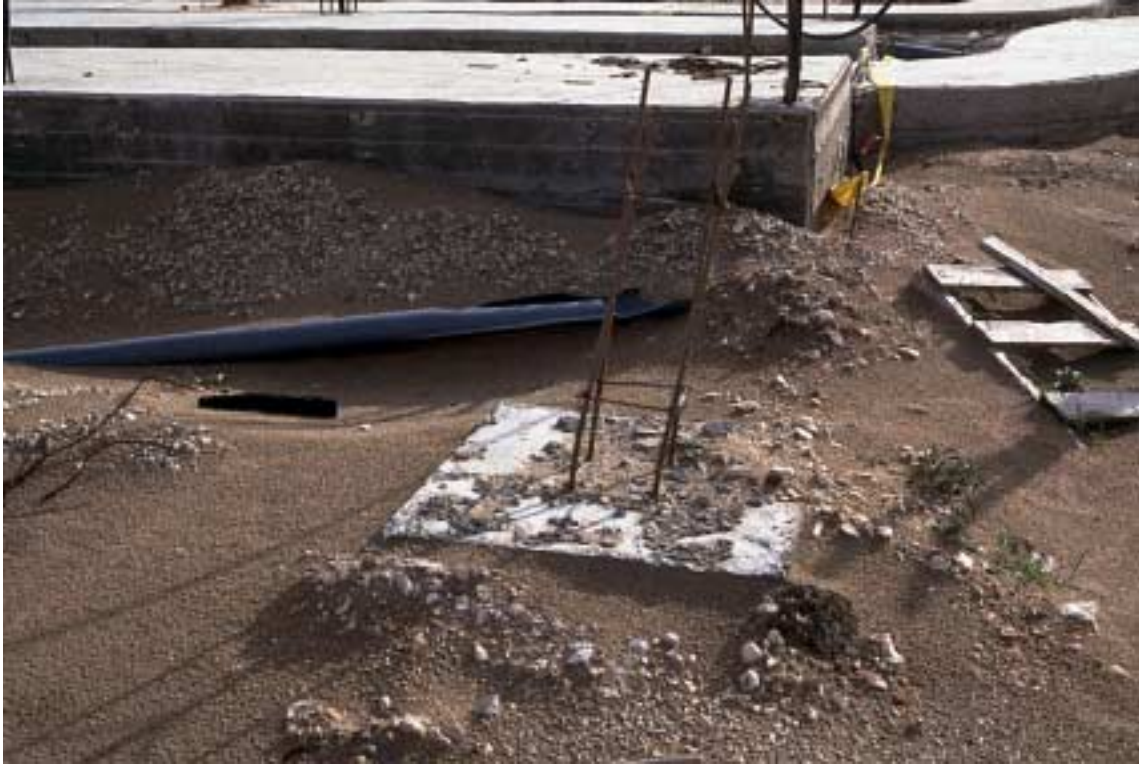
The debris had also mixed with the beach sand to a depth of more than a meter. The sand was washed and blown across the patrol road onto the construction site, bringing asbestos debris with it (*Figure 9*).

Figure 9. Sand and debris washed onto park site from beach. *[Full Size]*

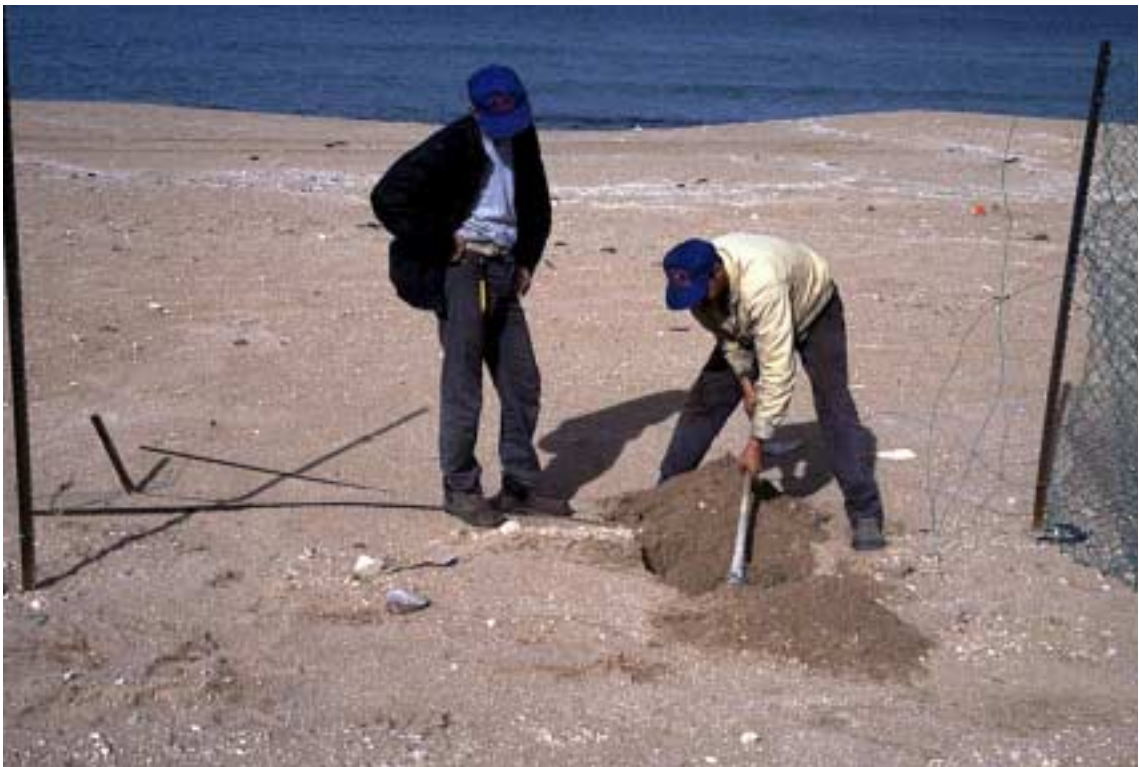
Workers at the site were observed to be disturbing the contaminated dirt without any protection against exposure to asbestos fibers, such as wearing respirators or wetting the dirt and debris (*Figure 10*). Air samples taken in 1997 during removal of contaminated dirt, when respirators were worn and the dirt was kept wet, had shown fiber levels below the Israeli exposure limit of 0.3 f/cm³ then in effect, but above the U.S. Permissible Exposure Limit of 0.1 f/cm³.

Figure 10. Workers digging hole in contaminated sand on beach. *[Full Size]*

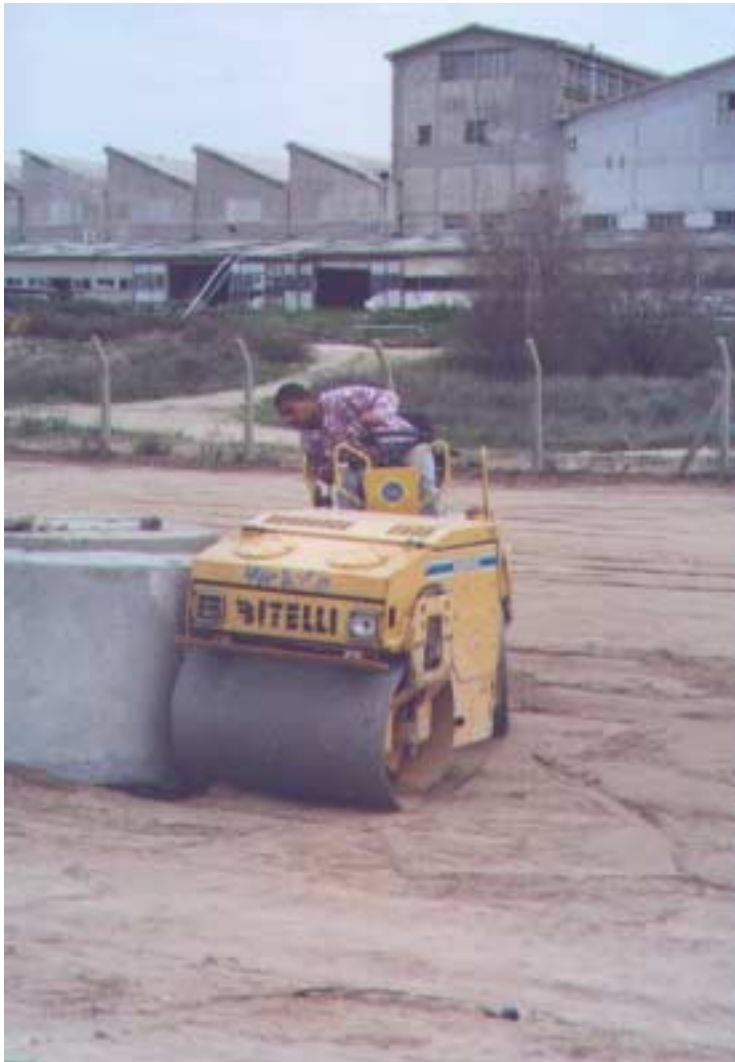
Figure 11. Packing dirt before installing protective membrane. *[Full Size]*

The ditch was filled in and the roadway raised to a level above the park site contours. All contaminated dirt was covered with a minimum of 20 cm of clean fill, which was packed down with a roller (*Figure 11*). To prevent upward migration of asbestos debris and also to provide a warning barrier in the event future excavation is necessary, a 2 mm thick geomembrane (used for hazardous waste control) was laid across the roadway and filled-in ditch, up to the fence (*Figure 12*). The seams of the membrane were heat-sealed to provide a leak-tight surface (*Figure 13*). The membrane was then covered with another 20 cm layer of clean fill (*Figure 14*).

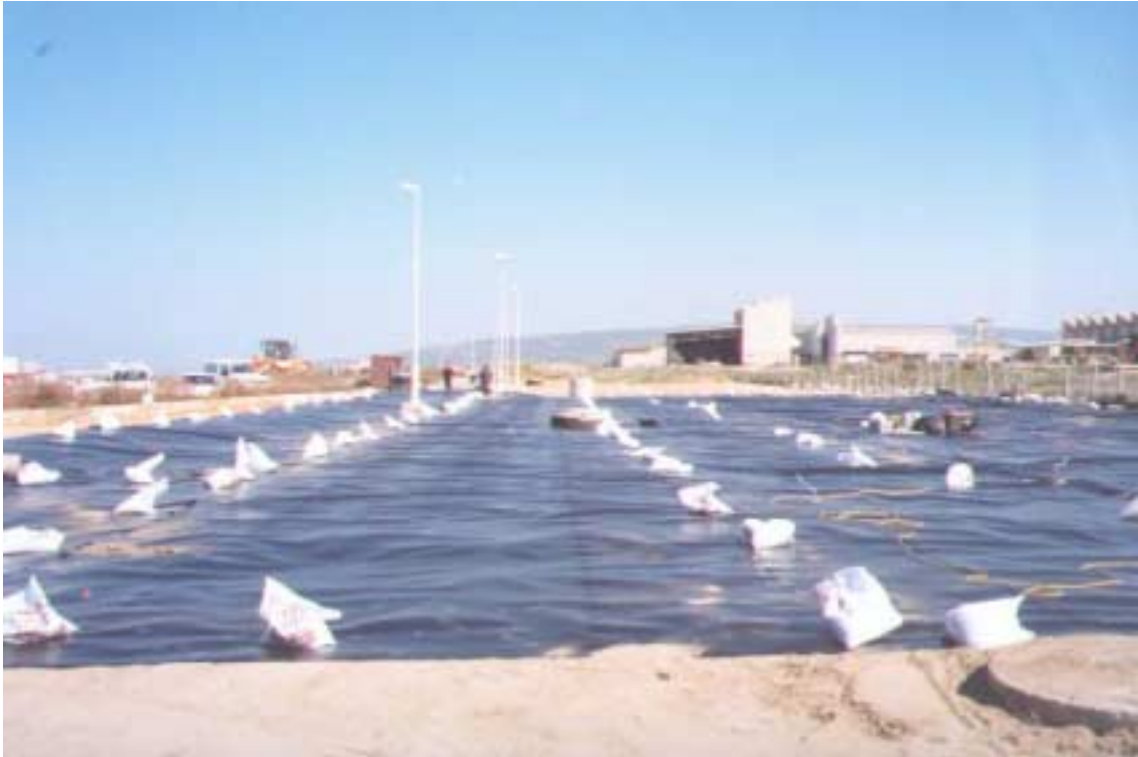
Figure 12. Geomembrane laid out over roadway area. *[Full Size]*

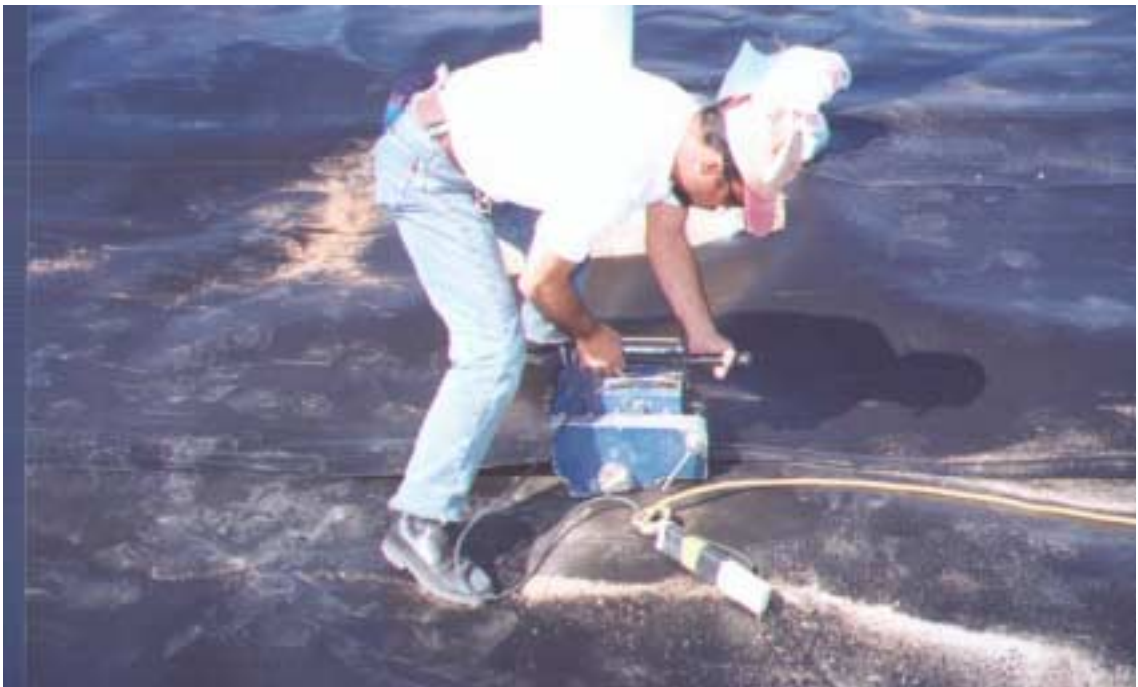
Figure 13. Heat-sealing seams of geomembrane. *[Full Size]*

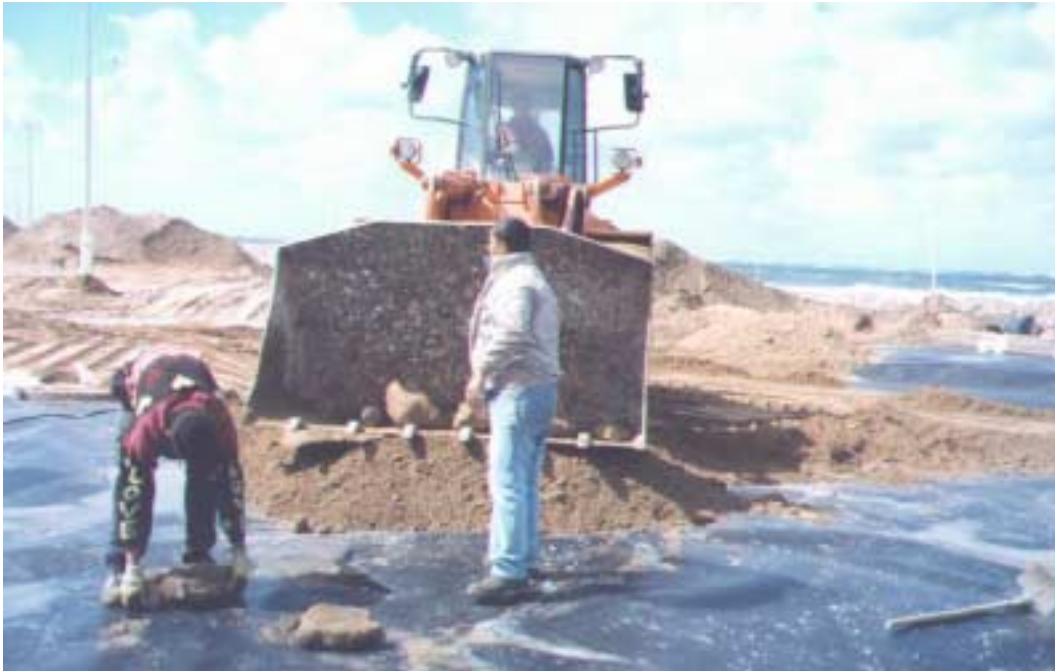
Figure 14. Covering geomembrane with clean fill dirt. [Full Size]

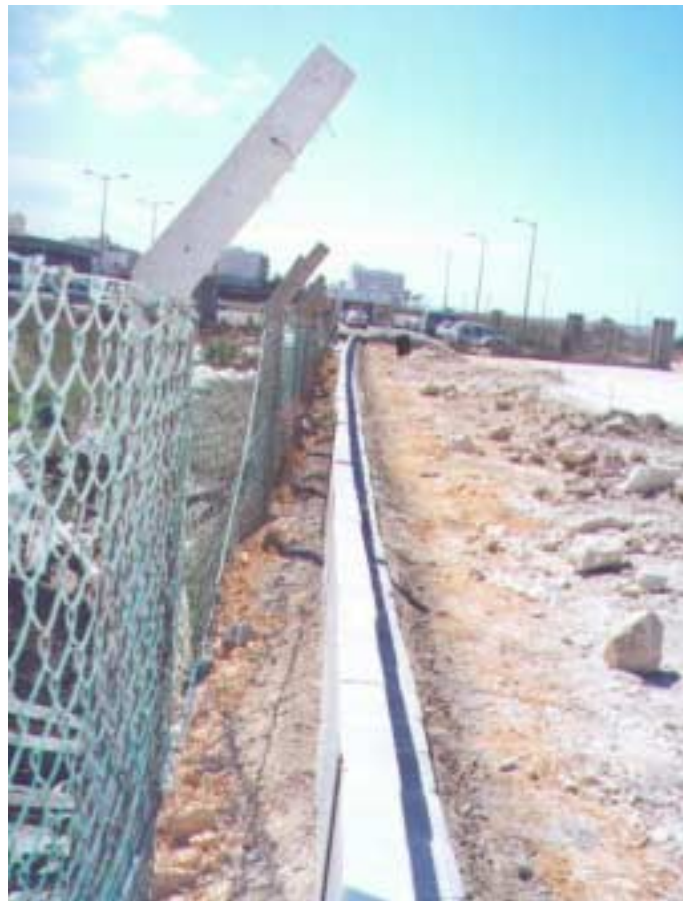
Figure 15. Wall along fence to collect contaminated run-off from plant site. [Full Size]

To prevent contaminated water from the plant from washing onto the remediated strip of land, a low wall was built just outside the fence. This wall will divert runoff to a collection pond at the south end of the plant (*Figure 15*).
