Poster Presentation

14.2 REMEDIATION OF LAND IN ISRAEL CONTAMINATED BY ASBESTOS CEMENT WASTE MATERIAL

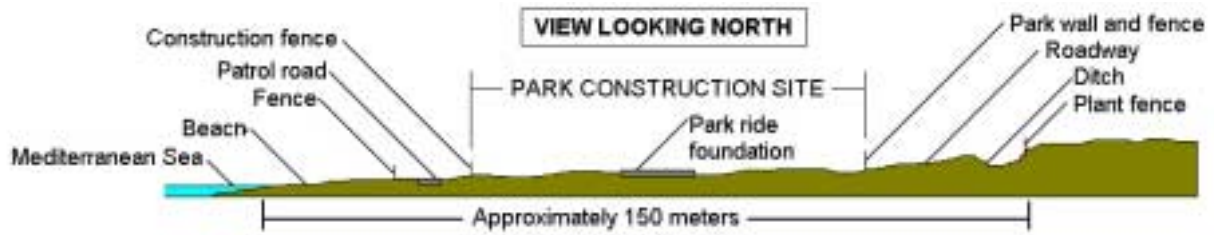
Beach sand was excavated to a depth of one meter in an attempt to remove the contamination. Due to the mobility of the beach sand, debris that is buried deeper than one meter continues to surface and the area remains off-limits for recreational purposes.

Figure 6 shows a cross-section of the area from the plant to the Mediterranean Sea.

Figure 6. Cross-section of park site from plant to beach.
