Poster Presentation

14.2 REMEDIATION OF LAND IN ISRAEL CONTAMINATED BY ASBESTOS CEMENT WASTE MATERIAL

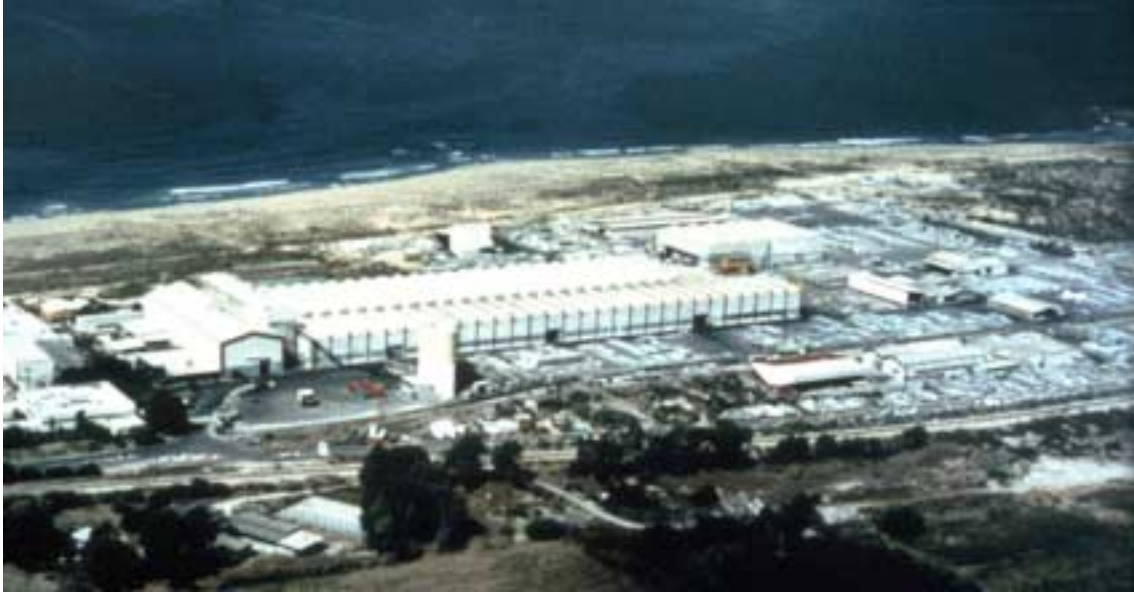
From 1952 to 1997, a plant in northern Israel manufactured asbestos-cement pipe and sheet products, using chrysotile, crocidolite and amosite asbestos fiber. An aerial view of this plant is shown in **Figure 1**. The friable and non-friable waste material from the manufacturing process (**Figure 2**) was partly disposed of in a slurry that ran through drainage trenches that are shown in **Figure 3**. This slurry contaminated property between the plant boundary and the Mediterranean Sea. Other wastes were buried under the ground in landfills around the plant.

The plant is closed and contaminated areas on plant property have been undergoing clean-up. The buildings and equipment are still in place and remain contaminated.

Figure 1. Aerial view of asbestos-cement products plant. *[Full Size]*
