POTENTIAL HEALTH HAZARDS OF ASBESTOS CEMENT ROOFING FOR INDIA'S POOR*

NICK CLARKE

The urban slum of New Lingarajapuram was chosen as illustrative of conditions found in slums throughout India, as the location for a survey. After presenting the context and data obtained in this survey the results are examined and wider issues surrounding asbestos use are discussed.

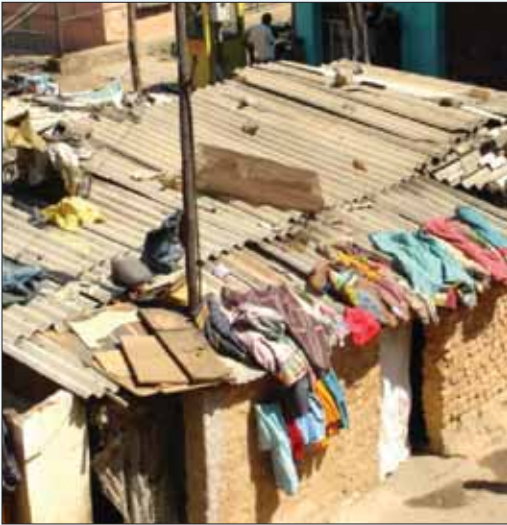
Typical AC roofing in New Lingarajapuram, Bangalore. Note lack of ventilation apart from that available by using the doorway.

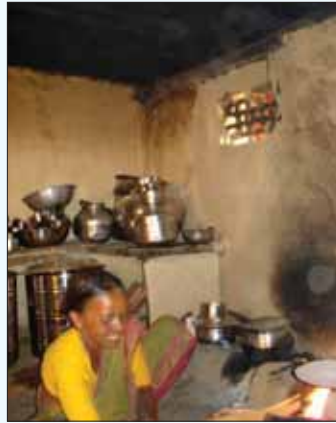
The effects of cooking over an open wood fire indoors. Note the ventilation 'window,' and the condition of the smoke blackened walls and AC ceiling. The occupants have lived in this dwelling for 16 years.

It is probable that smoke and heat cause most damage to the underside of AC roofing in slum contexts. This is a consequence of cooking inside over open fires in small dwellings generally having little or no ventilation (see photographs). Visits to various dwellings in the New Lingarajapuram slum as part of the Site Survey revealed that the vast majority of AC roofing was in poor condition. Over time, the crusting of smoke soot on the underside of the roof solidifies and eventually flakes off, appearing to pit and damage the AC. This increases the likelihood that harmful chrysotile fibers are released into the surrounding environment. In addition, the survey found many AC panels that had been cracked or broken. It is possible that this premature deterioration has been caused by both smoke and heat damage. Exposure to such elements is likely to make the product increasingly brittle and consequently more friable. Added to that is the fact that when AC roofing is cracked or broken, harmful chrysotile fibers are released in significant numbers due to the pull out effect as discussed by Dyczek.¹⁴ Importantly, the lack of ventilation prevalent in most dwellings means that any chrysotile fibers released as a result of damaged roofing are largely trapped inside the dwelling, thereby increasing the chance of occupant exposure and inhalation. The fact that most dwellings are small and overcrowded further exacerbates the potential of this problem.

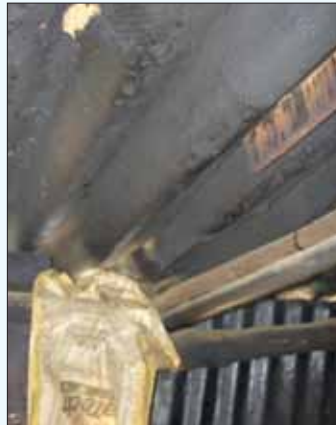
Pitting and smoke damage on AC roofing after long-term use (same dwelling as above).

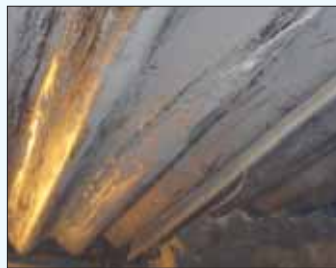
Charred and cracked AC roofing after long-term use (same dwelling as above).

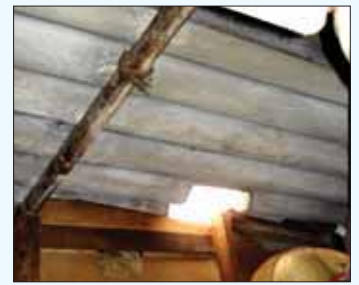
Homemade skylight cut into AC roofing, the cutting of which releases harmful chrysotile fibres into the environment. The roof has been previously painted with white emulsion paint which deteriorates rapidly, often showing signs of discolouration and mould. Note the contrast in ceiling colour when compared to white ceiling fan (top right).

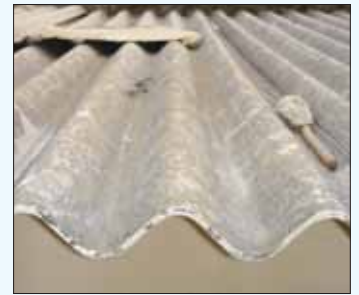
Exterior AC roofing in reasonable condition. Note surface weathering.

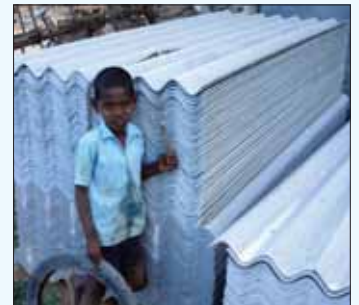
Typical display of corrugated AC roofing for Sale, Kothanur, Greater Bangalore (Reesearcher, Supplier Survey, February 3rd, 2006).

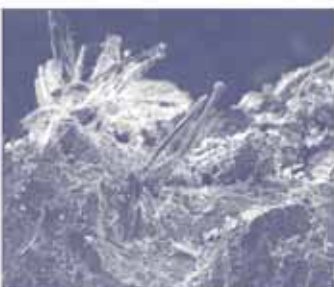
- The asbestos fibres are sticking out due to the pull out effect. This occurs when composite materials that are reinforced by short fibers are fractured or cracked, as in the case of AC (2004:8).
- The fibres observed differed in both length and relative dimensions. "Any mechanical influence on these protruding fibres may produce a large number of asbestos dust particles" (ibid.).
- "From one asbestos fibre, protruding as we see in Photo 12 [sic], we may get hundreds or thousands of respirable asbestos fibres; it is only a question of even feeble mechanical action or other tension. For example, movement caused by thermal expansion could be sufficient" (ibid.).

Asbestos Fibres on a Broken AC Sheet. SEM magnification 200x (Dyczek, 2004:8).
